CDNSWC-SME-92/32 August 1992

Ship Materials Engineering Department

Research and Development Report

**The Effect of a Seawater Environment on the
Galvanic Corrosion Behavior of Graphite/Epoxy
Composites Coupled to Metals**

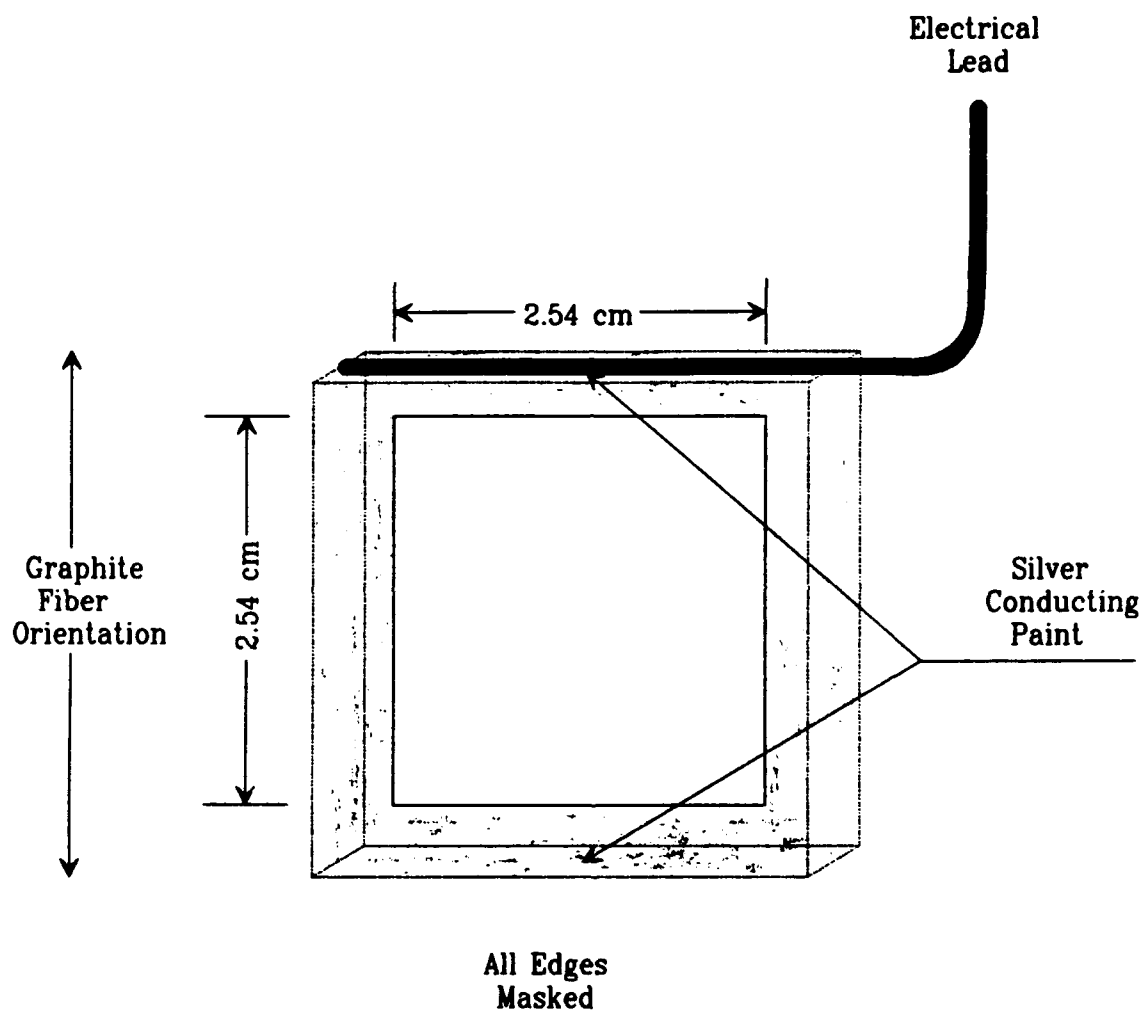
Figure 1. Gr/epoxy composite specimen used for galvanic corrosion testing.

Galvanic corrosion tests were conducted for 180 days in quiescent, filtered, natural seawater at ambient temperature. The testing was performed at the LaQue Center for Corrosion Technology (LCCT). The galvanic couples consisted of HY80 steel and NAB individually connected to Gr/epoxy composites in the following conditions: (a) as-fabricated composite, (b) one composite face hand-sanded to expose graphite fibers and one composite face as-fabricated, (c) two composite faces hand-sanded to expose graphite fibers, or (d) one composite face machine-sanded to expose graphite fibers.

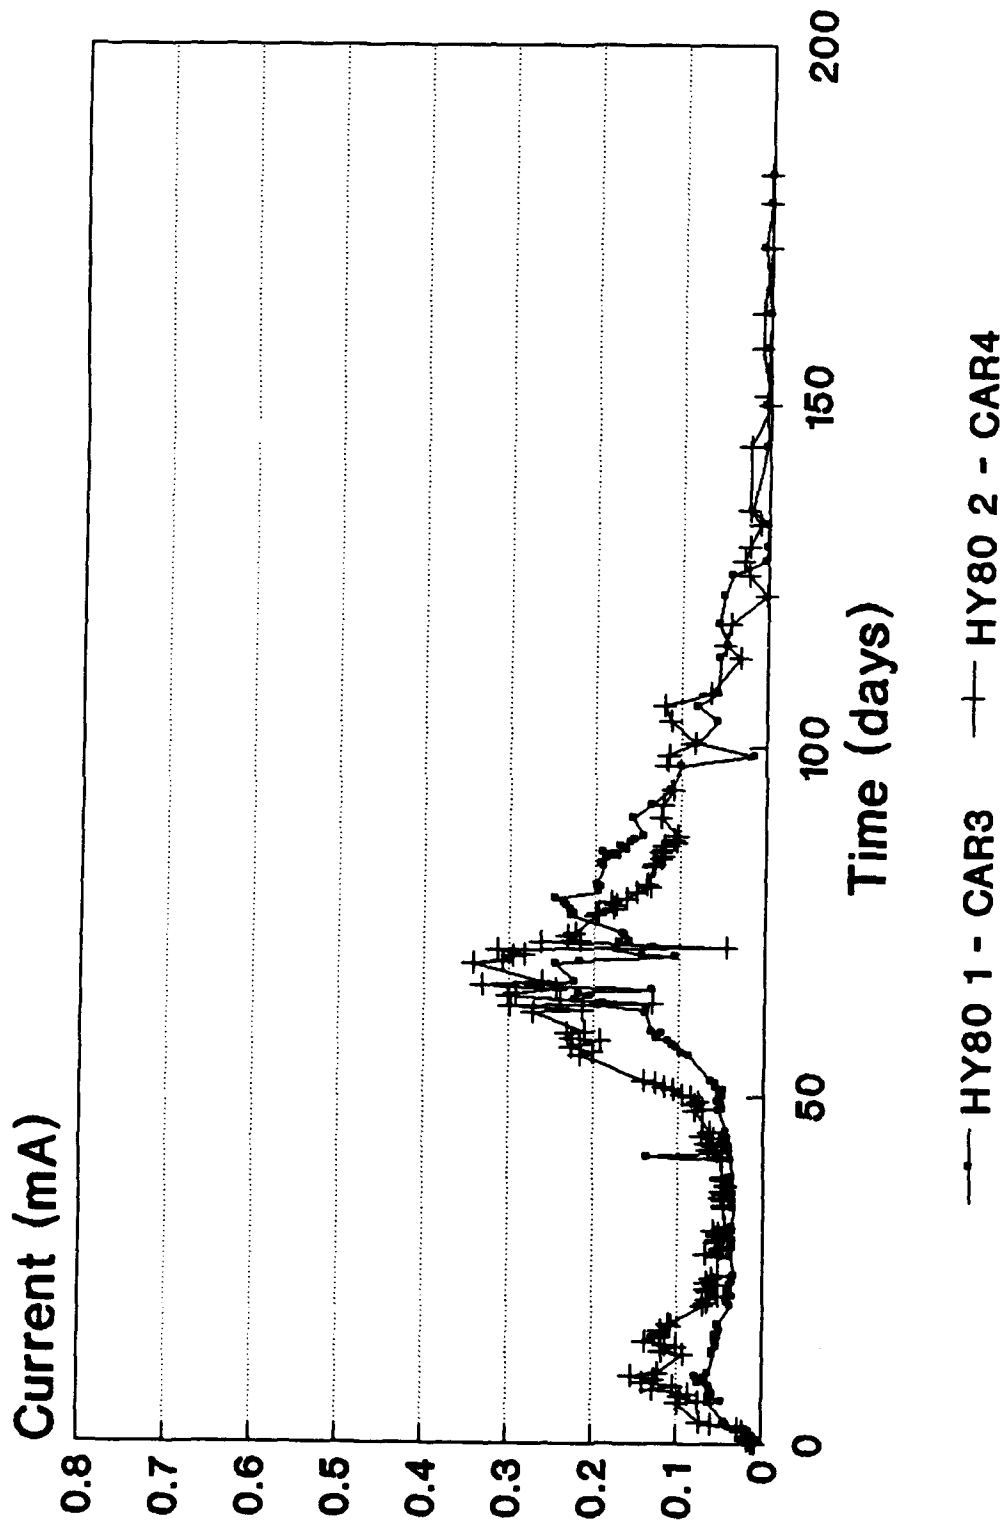
Figure 2. Galvanic current data for HY80 steel - CAR (Gr/epoxy composite with no graphite fibers initially exposed).

Current versus time data for the HY80-composite galvanic couples is included in Figures 2-5. The current data for all of the HY80-composite couples indicated an initial rise in current immediately after exposure to seawater. The amount of the initial current increase varied among the different composite specimen types coupled to HY80, and it was found to be related to the percentage of graphite fibers initially exposed in the

It should be noted that the HY80-CAR and NAB-CAR couples did display an increase in the current level almost immediately upon seawater exposure (Figures 2 and 7) even though these composites contained an approximately 0.01 mm thick epoxy layer on their surfaces, which initially prevented any graphite fibers from being exposed to the environment. A computer program (10) based on Fickian diffusion was used in this study to estimate the time required for moisture to penetrate through the epoxy layer to the graphite fibers within the composite. Input for this program included a resin diffusivity of 1.48×10^{-6} in²/hour and a maximum moisture content of the resin equal to 6%. The basis for the selection of these input values is explained in reference (11). The program calculations showed that moisture could penetrate through the epoxy layer to the graphite fibers within ten minutes after exposure, which is consistent with the increase in the

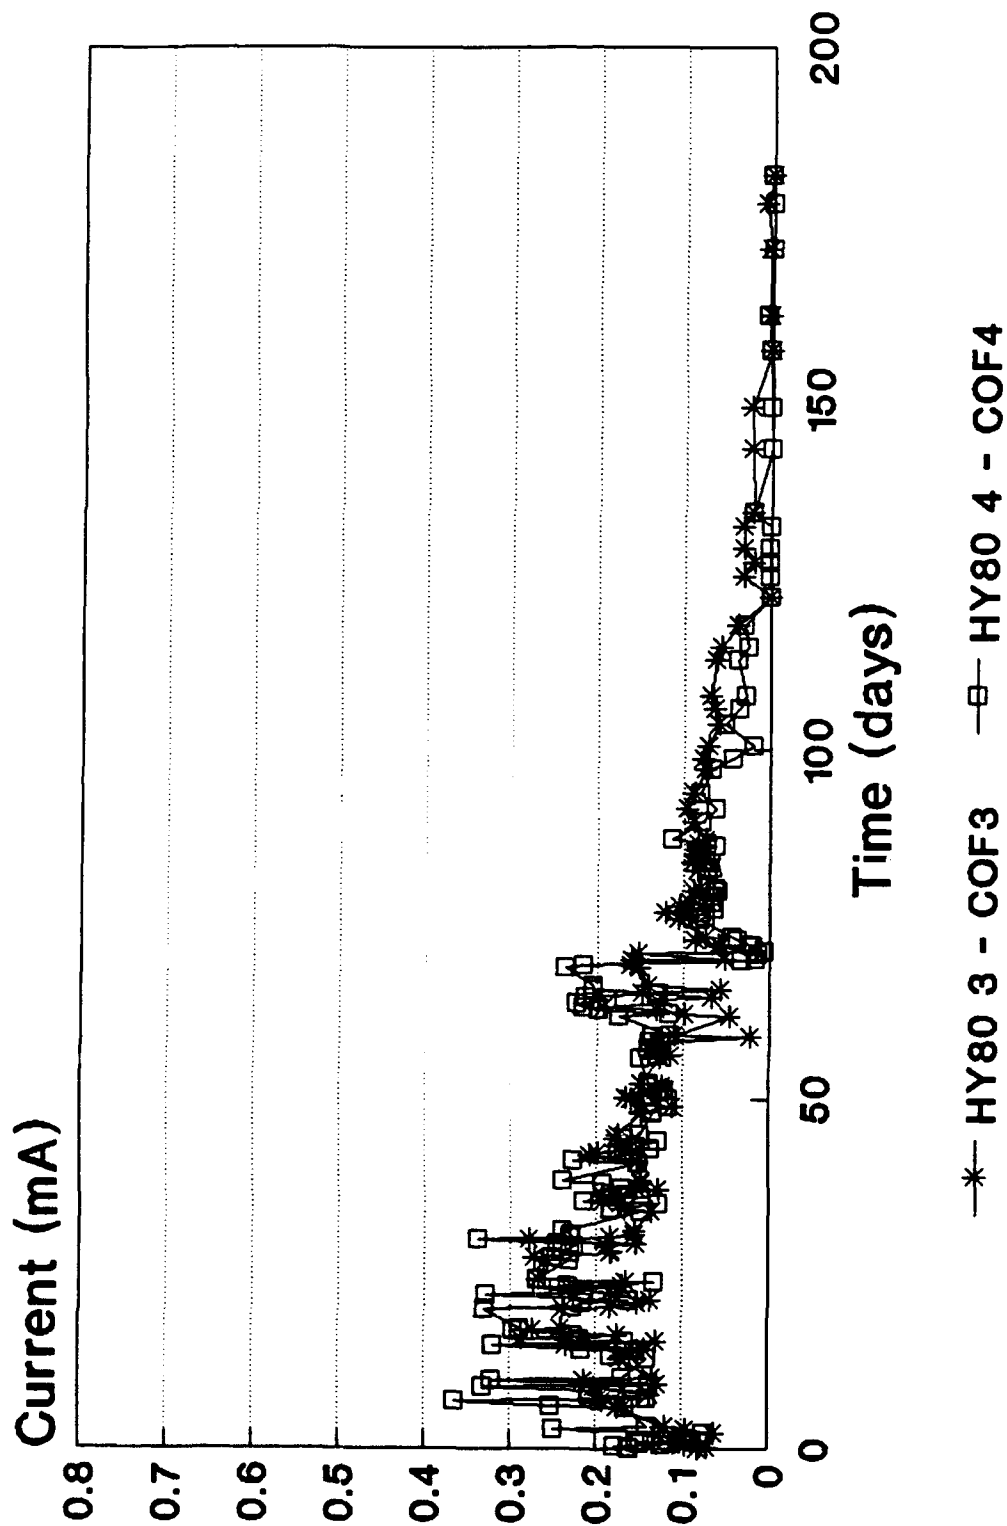
Figure 3. Galvanic current data for HY80 steel - COF (Gr/epoxy composite with one face hand sanded to initially expose a minimum 4% graphite fiber area on surface).

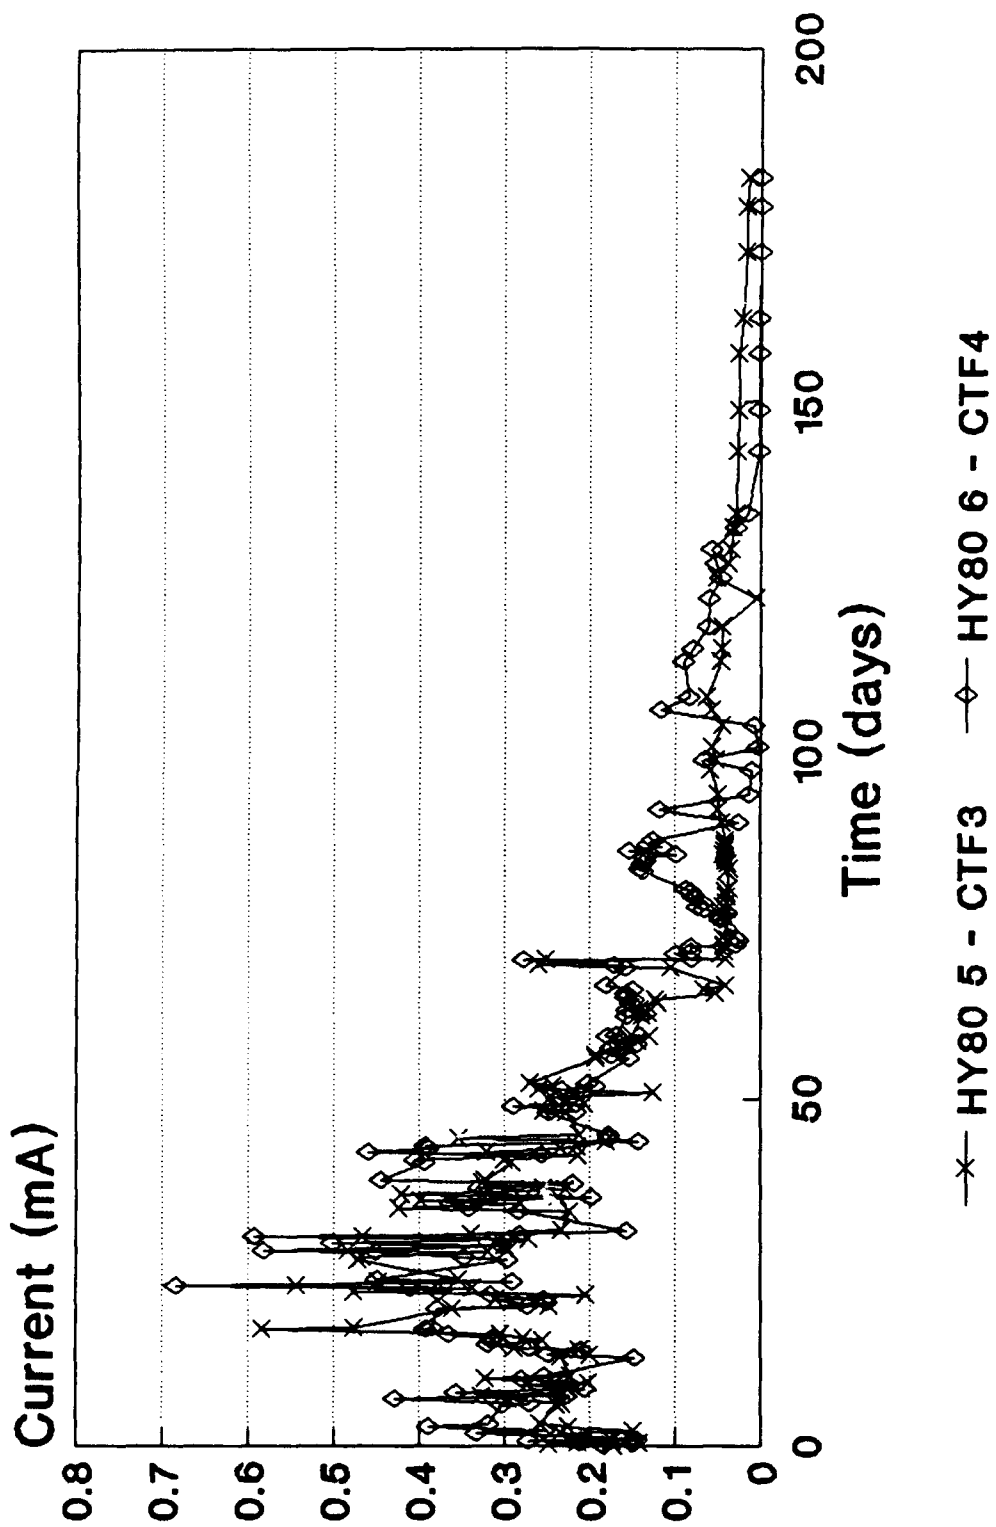
Figure 4. Galvanic current data for HY80 steel - CTF (Gr/epoxy composite with two faces hand sanded to initially expose a minimum 8% graphite fiber area on surface).

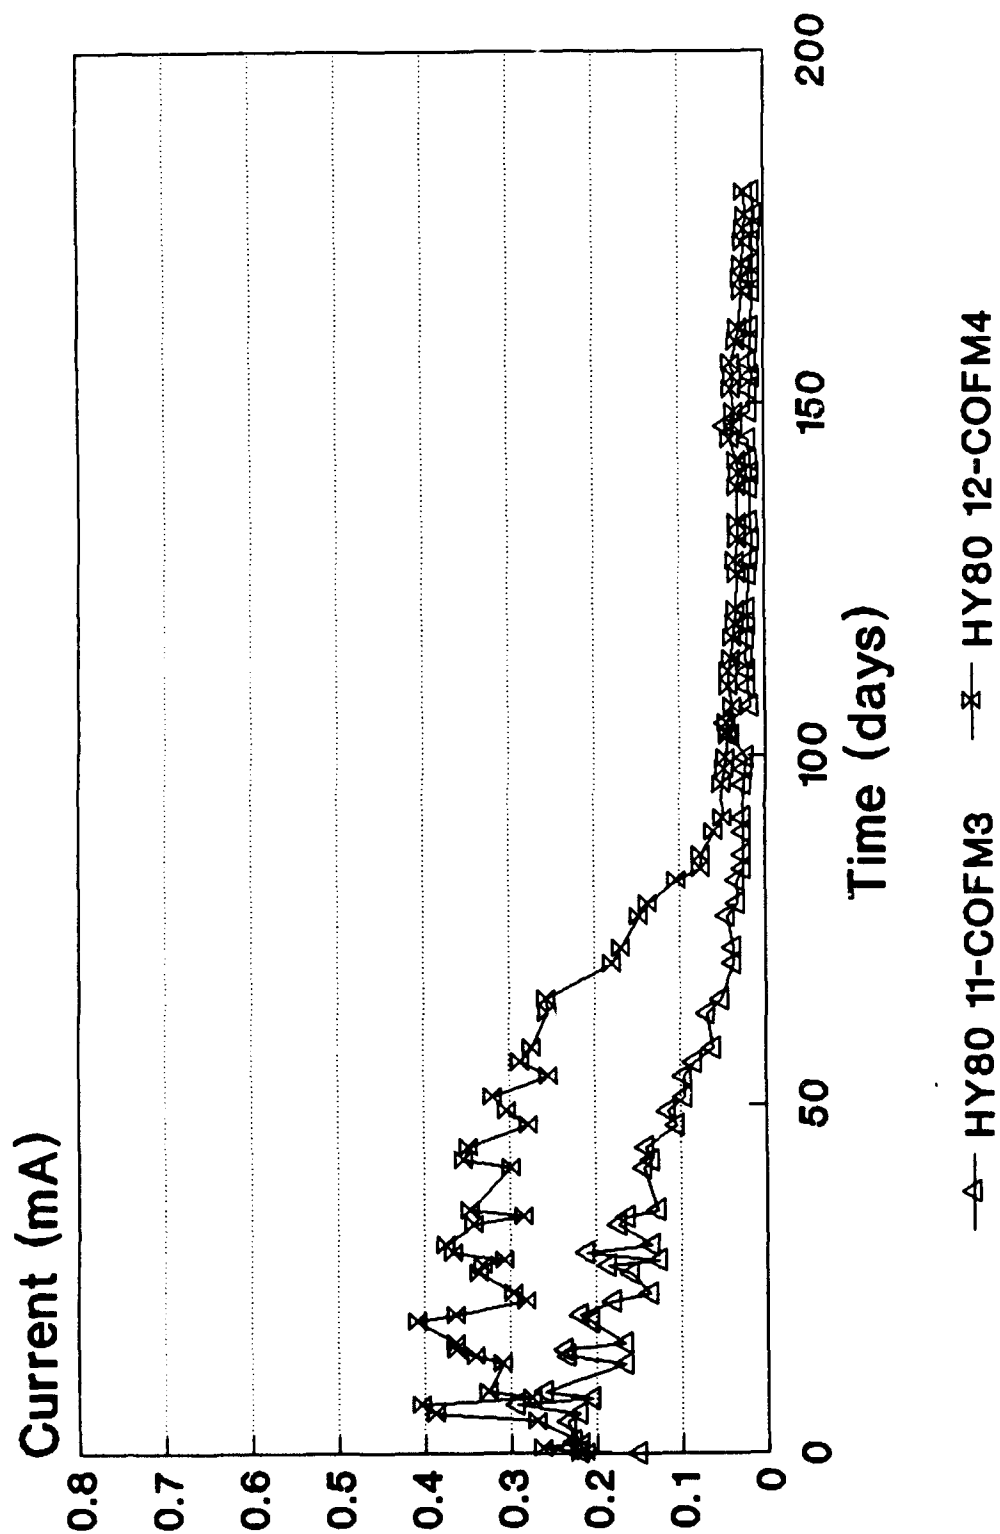
Figure 5. Galvanic current data for HY80 steel - COFM (Gr/epoxy composite with one face machine sanded to initially expose a minimum 68% graphite fiber area on surface).

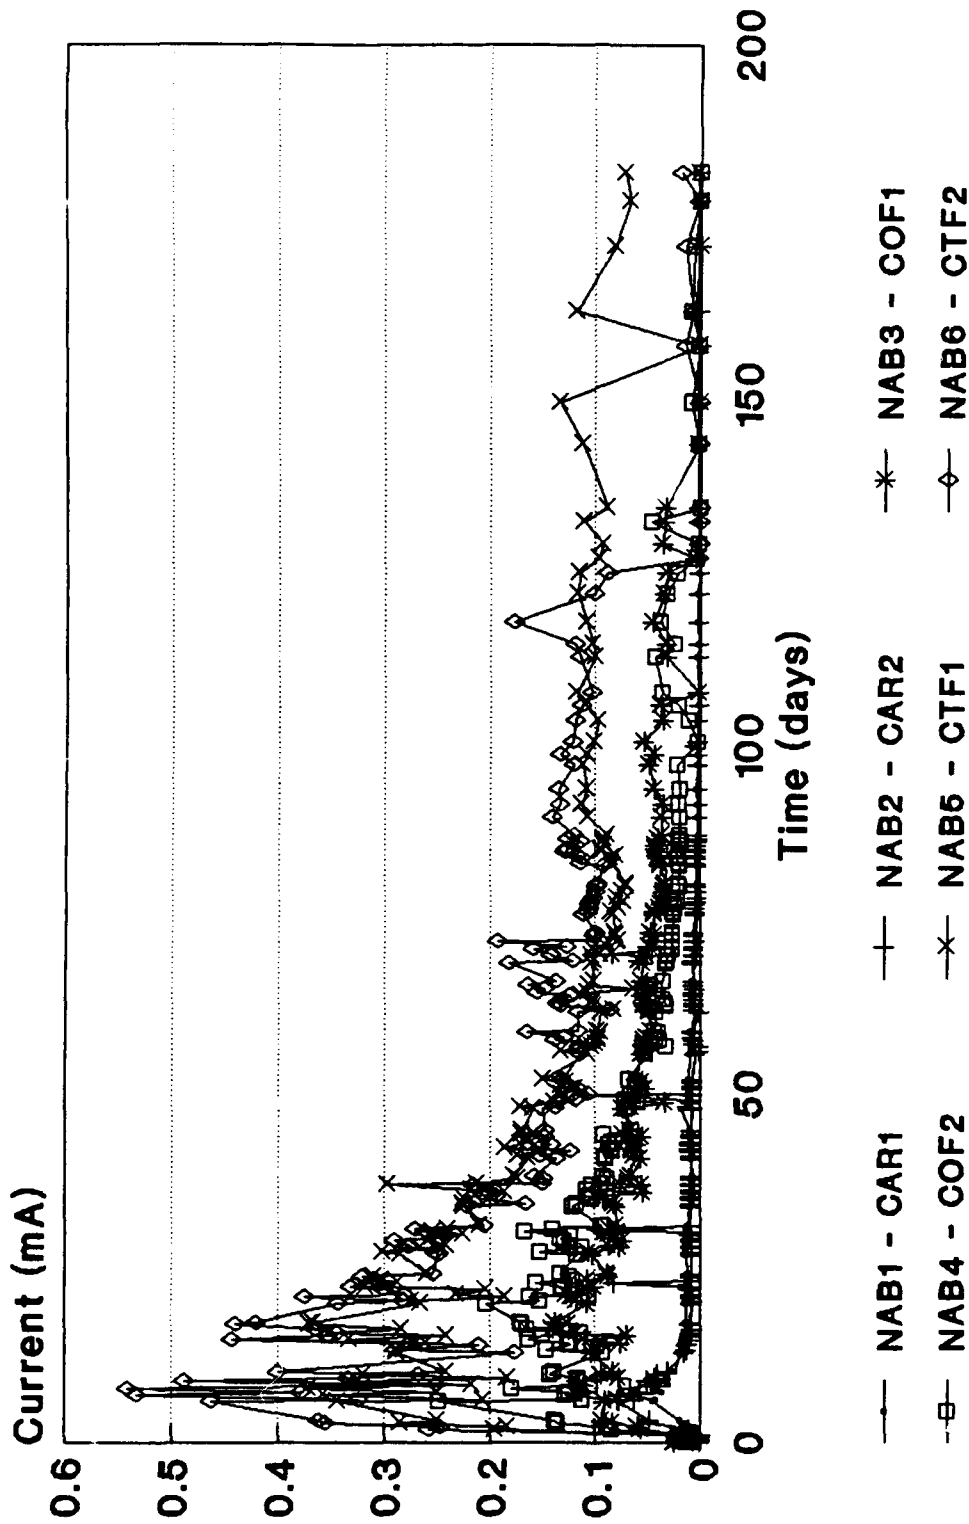
Figure 7. Galvanic current data for nickel aluminum bronze (NAB) coupled to Gr/epoxy composites labeled as CAR (no graphite fibers initially exposed), COF (minimum 4% graphite fiber area initially exposed), and CTF (minimum 8% graphite fiber area initially exposed).

Current versus time data for the NAB-composite galvanic couples is included in Figures 7 and 8. As seen in these figures, all of the NAB-composite couples exhibited a rise in current immediately after seawater exposure. The amount of the initial current increase was found to be related to the percentage of graphite fibers initially exposed in the Gr/epoxy composites. A similar trend in the initial current data was exhibited by the HY80-composite couples.

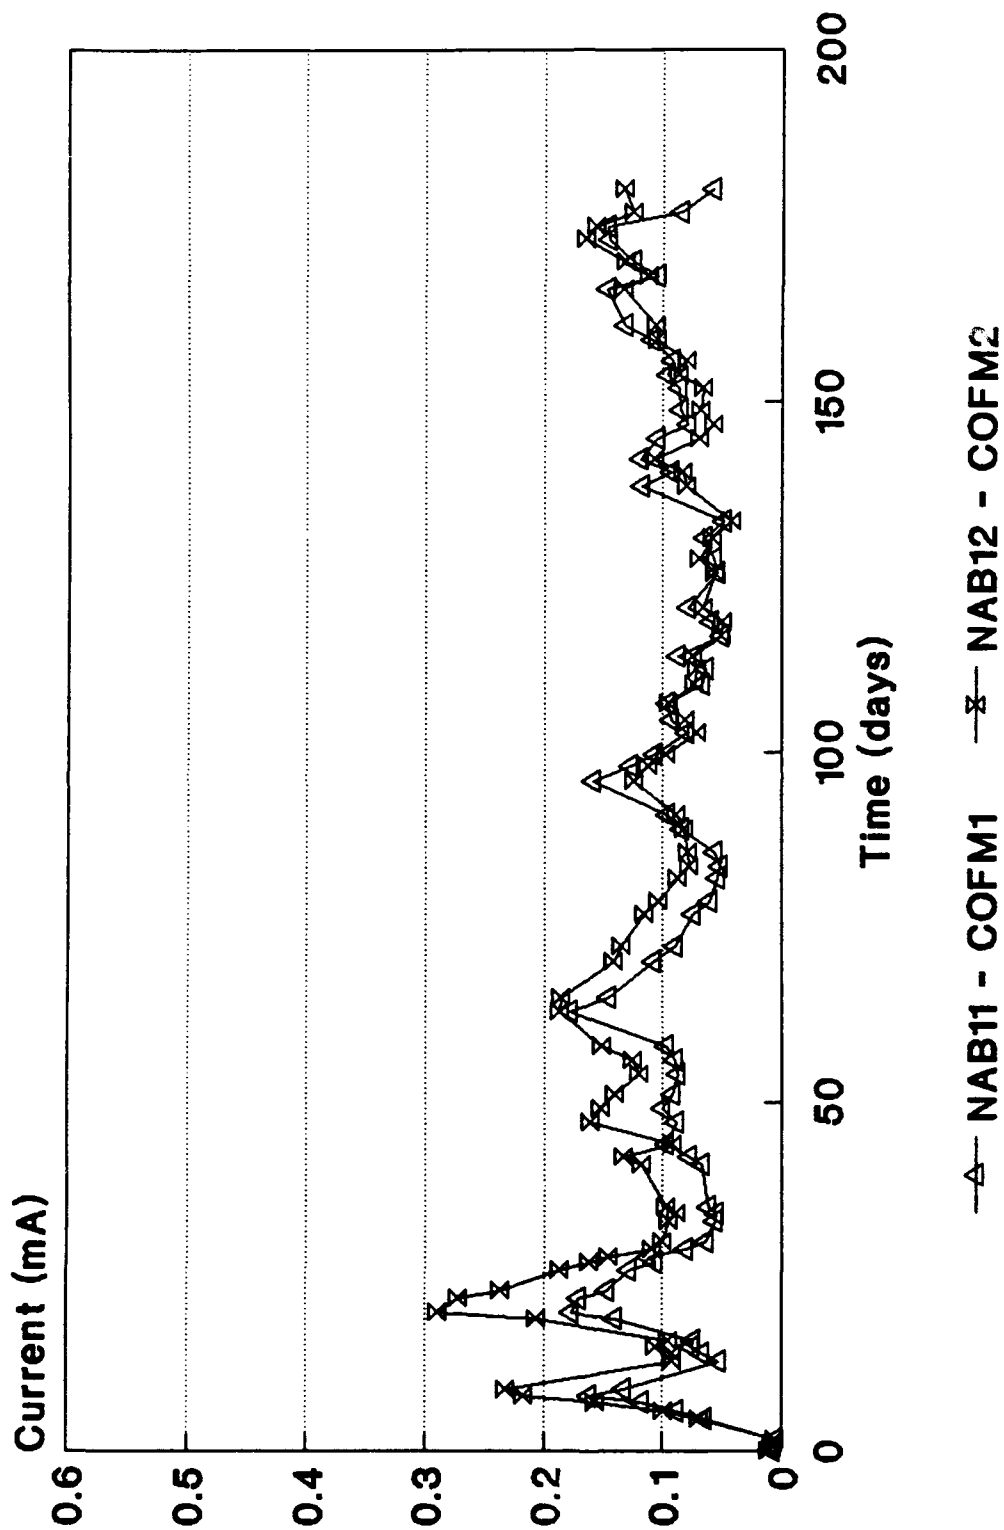
Figure 8. Galvanic current data for nickel aluminum bronze (NAB) - COFM (Gr/epoxy composite machine sanded to initially expose a minimum 68% graphite fiber area on surface).

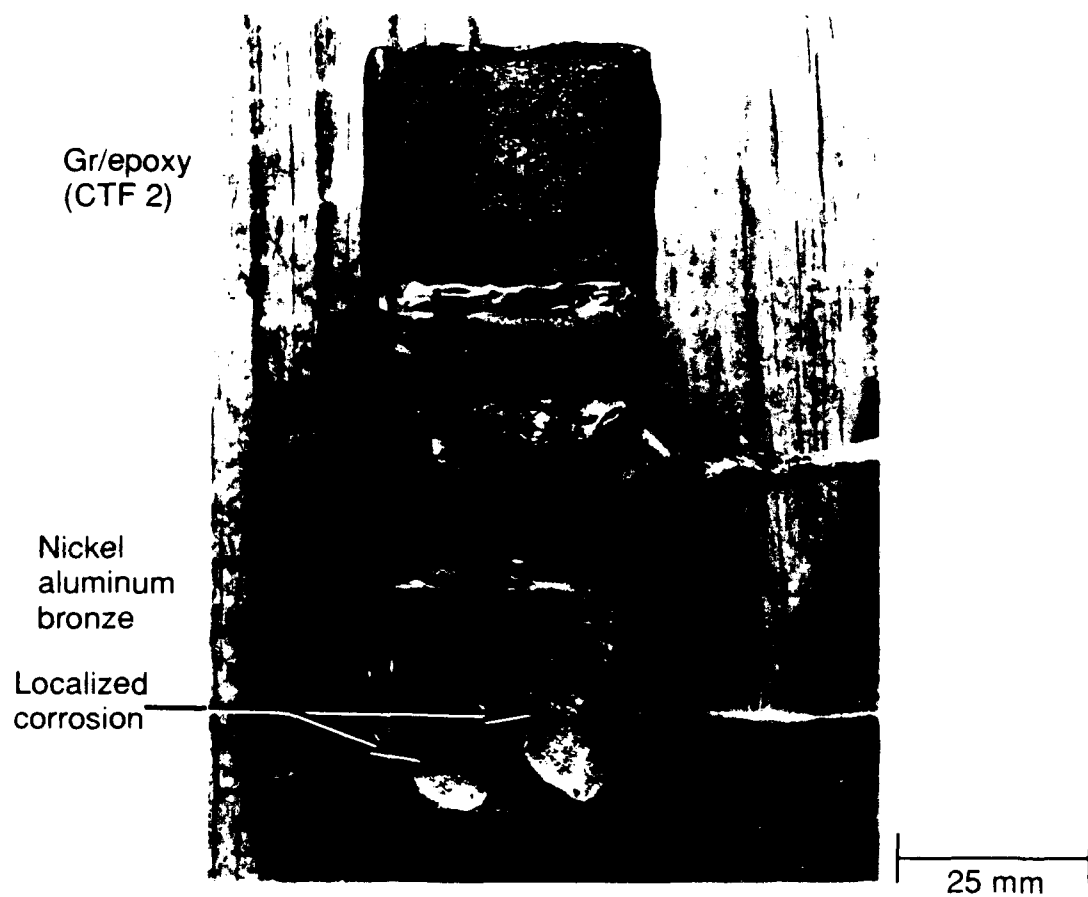
Figure 9. Nickel aluminum bronze - Gr/epoxy composite galvanic couple specimens after 180-day seawater testing (NAB specimen is representative of severe localized corrosion present on NAB specimens coupled to COF, CTF, and COFM Gr/epoxy composites).

At the conclusion of the 180-day galvanic corrosion tests, the NAB specimens from the NAB-composite galvanic couples contained greenish-brown and brown corrosion products in localized areas on their surfaces. As in the HY80 tests, the Gr/epoxy composites from these NAB-composite galvanic couples had tenacious calcareous deposits on their surfaces. Figure 9 shows a photograph of one NAB-CTF galvanic couple at the conclusion of the seawater testing. The specimen surfaces had been brush cleaned to remove the bulk of the corrosion products prior to photographing. The photograph in Figure 9 represents the localized corrosion typically present on the NAB surfaces after the NAB-composite galvanic couple testing was completed, but the depth and quantity of pitting present varied among the various galvanic couples.

All of the NAB specimens from the NAB-composite galvanic couples exhibited localized corrosion that was predominantly oriented along the

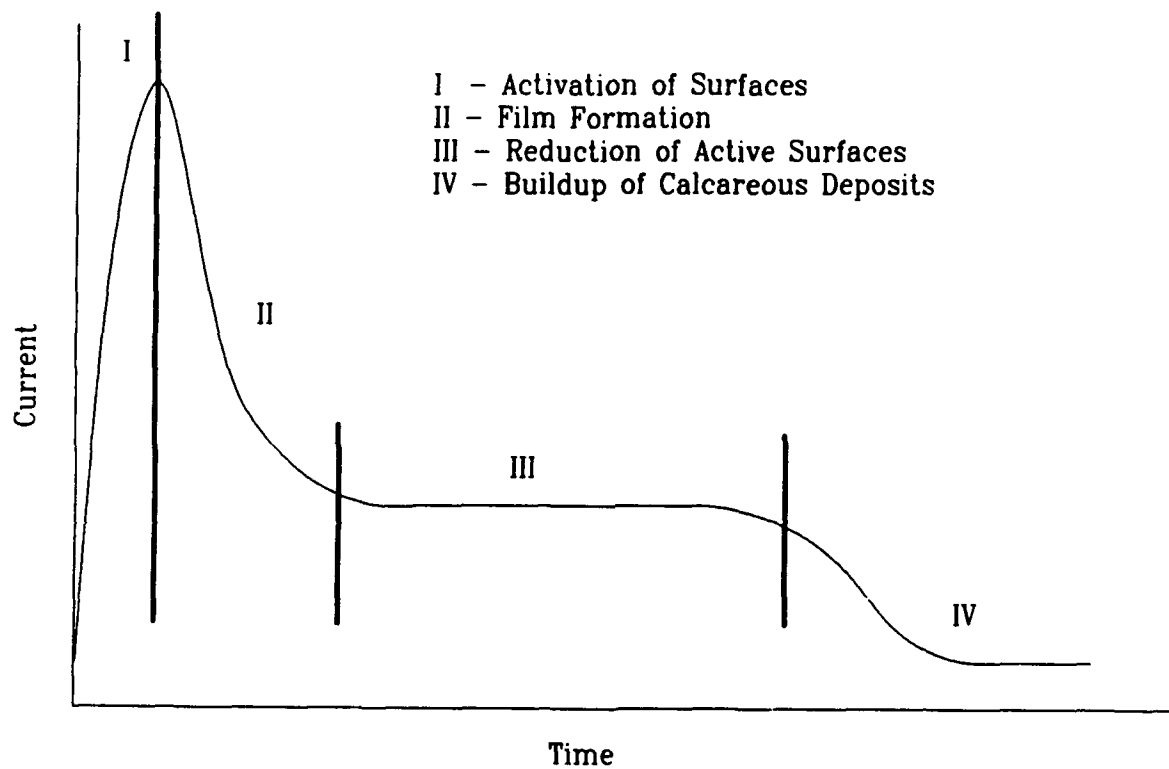
Figure 10. Current trends as determined from the composite-metal galvanic couple testing.

The current trends determined from the galvanic couple testing are incorporated into the plot shown in Figure 10. This plot divides the current versus time curve into four distinct regions. Region I shows the initial current increase upon exposure in seawater, which was attributed to the activation of both the metal and graphite fiber surfaces by immersion in seawater. As corrosion product films were formed on the active surfaces,

All of the HY80-composite and NAB-composite couples displayed the initial current increase and subsequent reduction in current as described for Regions I and II, but after that variations from Figure 10 were evident for individual galvanic couples. In general, it was found that the

The HY80-COF, HY80-CTF, NAB-COF, and one of two NAB-CTF couples exhibited the four regions of corrosion current behavior as depicted in Figure 10. The HY80-COFM couple and the remaining NAB-CTF couple displayed corrosion currents as defined by Regions I through III, but never showed the Region IV reduction in current to very low levels. In addition, the NAB-COFM couples showed the initial current rise and subsequent reduction in current but did not exhibit a stable current level by the end of the 180-day test. The active currents evident in the HY80-COFM, NAB-COFM, and one NAB-CTF couple are presumably related to active surface areas of graphite fibers available to promote the galvanic corrosion reaction with the metal surface, thus preventing a reduction in the current level to negligible values.

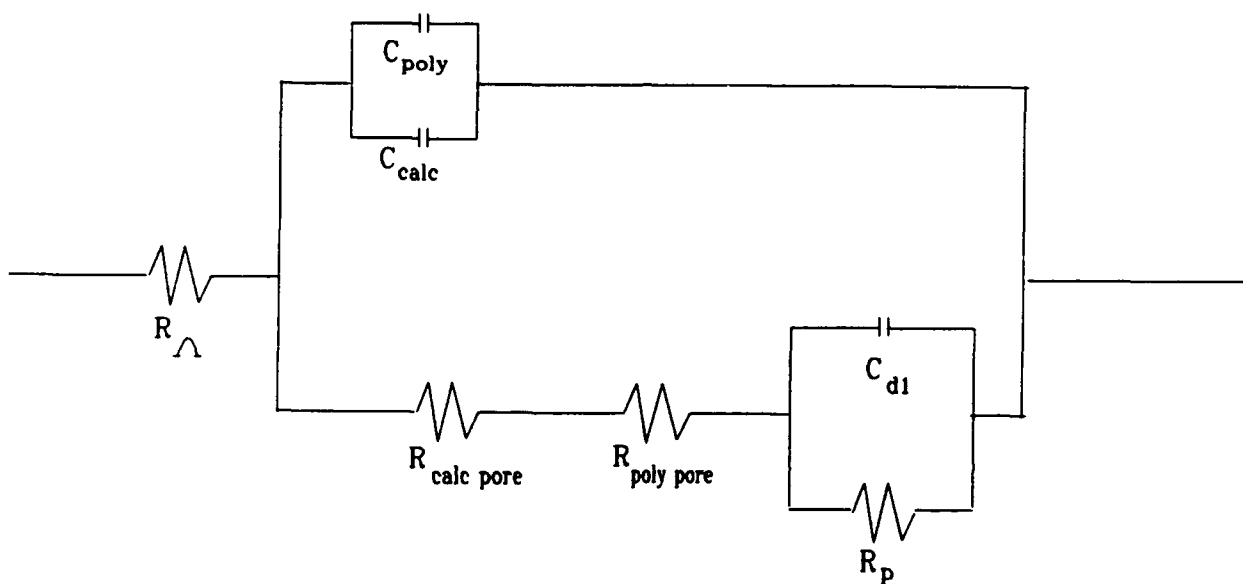
Figure 11. Nested equivalent circuit for Gr/epoxy composite with calcareous deposit.

where C_{poly} = capacitance (polymer)
 C_{calc} = capacitance (calcareous deposit)
 R_{Ω} = solution resistance
 $R_{calc\ pore}$ = resistance (pores in calcareous deposit)
 $R_{poly\ pore}$ = resistance (pores in polymer (Gr/epoxy composite))
 C_{dl} = double layer capacitance
 R_p = polarization resistance

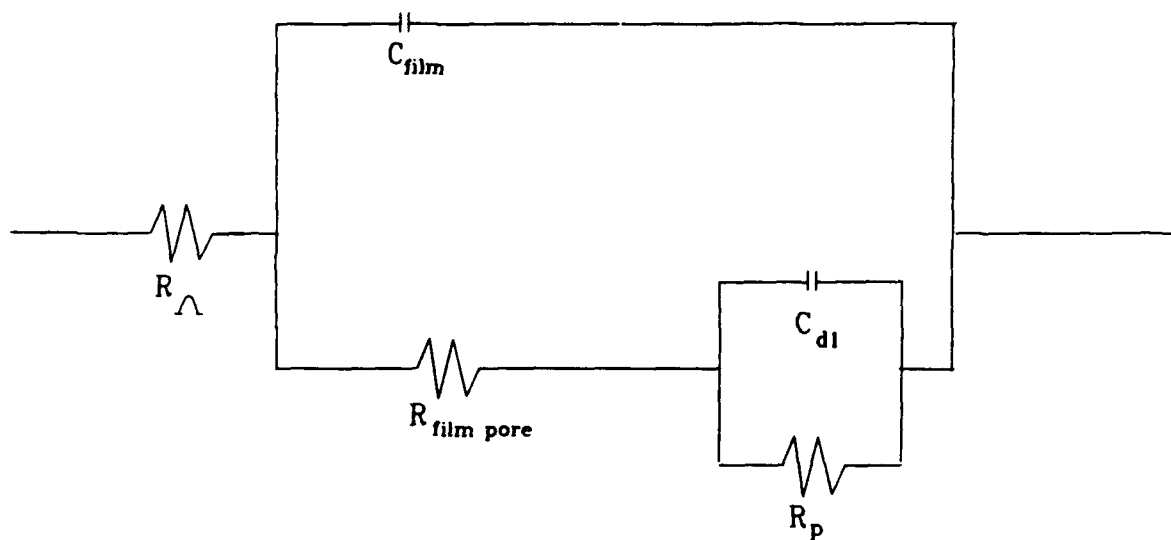
Figure 12. Simplified nested equivalent circuit for coupled Gr/epoxy composite with calcareous deposit.

where C_{film} = film capacitance
 R_{Ω} = solution resistance
 $R_{film\ pore}$ = resistance (pores in film)
 C_{dl} = double layer capacitance
 R_p = polarization resistance

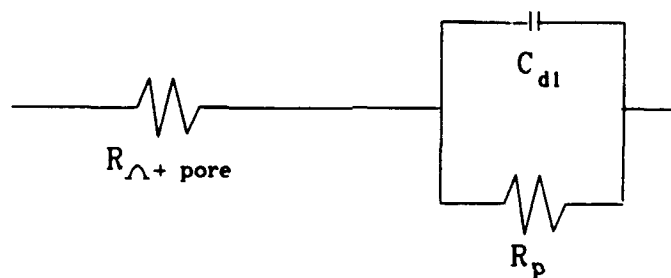
Figure 13. Simplified nested equivalent circuit for uncoupled Gr/epoxy composite without calcareous deposit.

where C_{dl} = double layer capacitance
 R_p = polarization resistance
 $R_{\Omega + pore}$ = resistance (solution + pores in film)

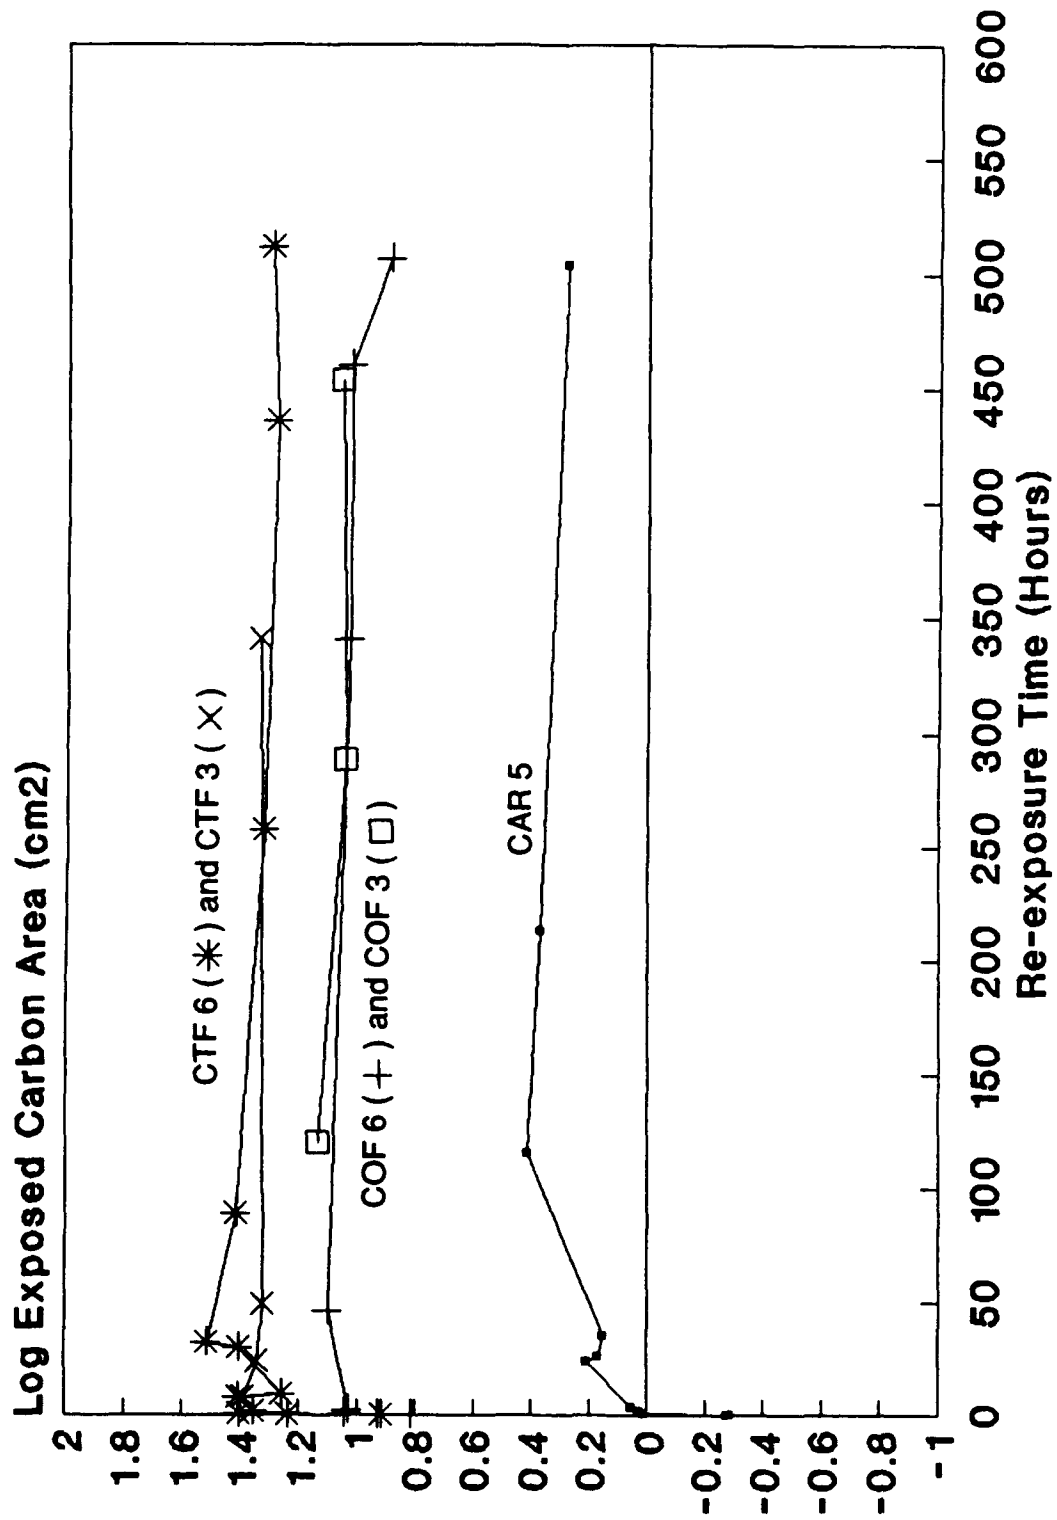
Figure 14. Exposed graphite fiber surface area versus re-exposure time for Gr/epoxy composite specimens (calculated from EIS data).

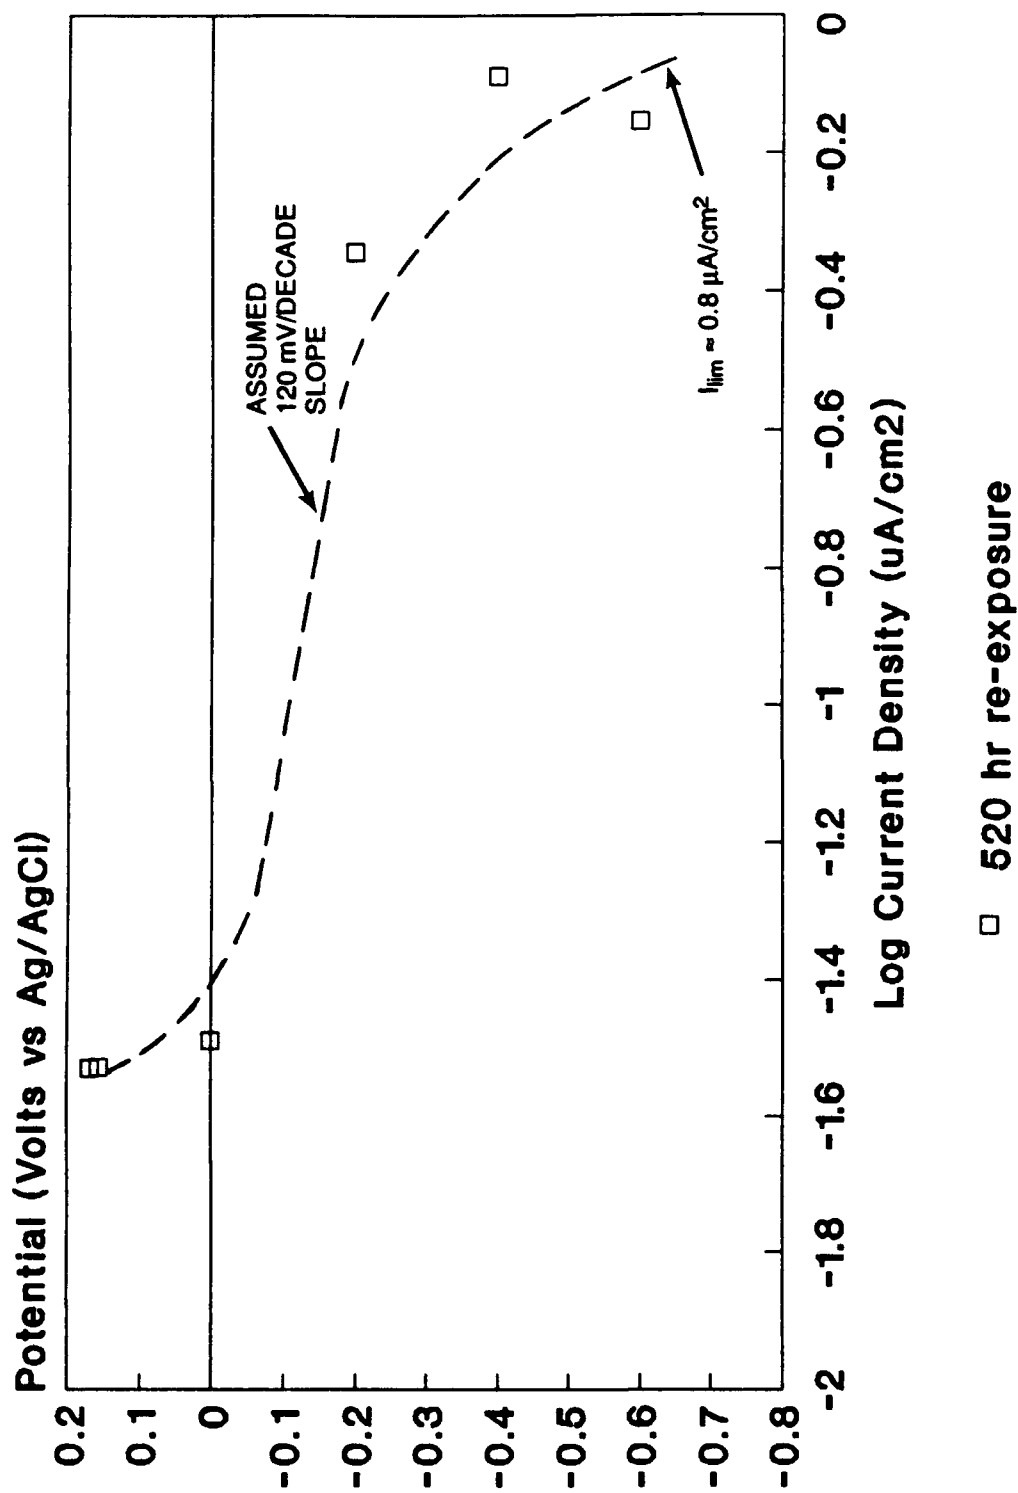
Figure 15. Cathodic behavior of Gr/epoxy composite specimen COF 6 (uncoupled specimen with one face as-fabricated) using electrochemical impedance spectroscopy at controlled potentials.

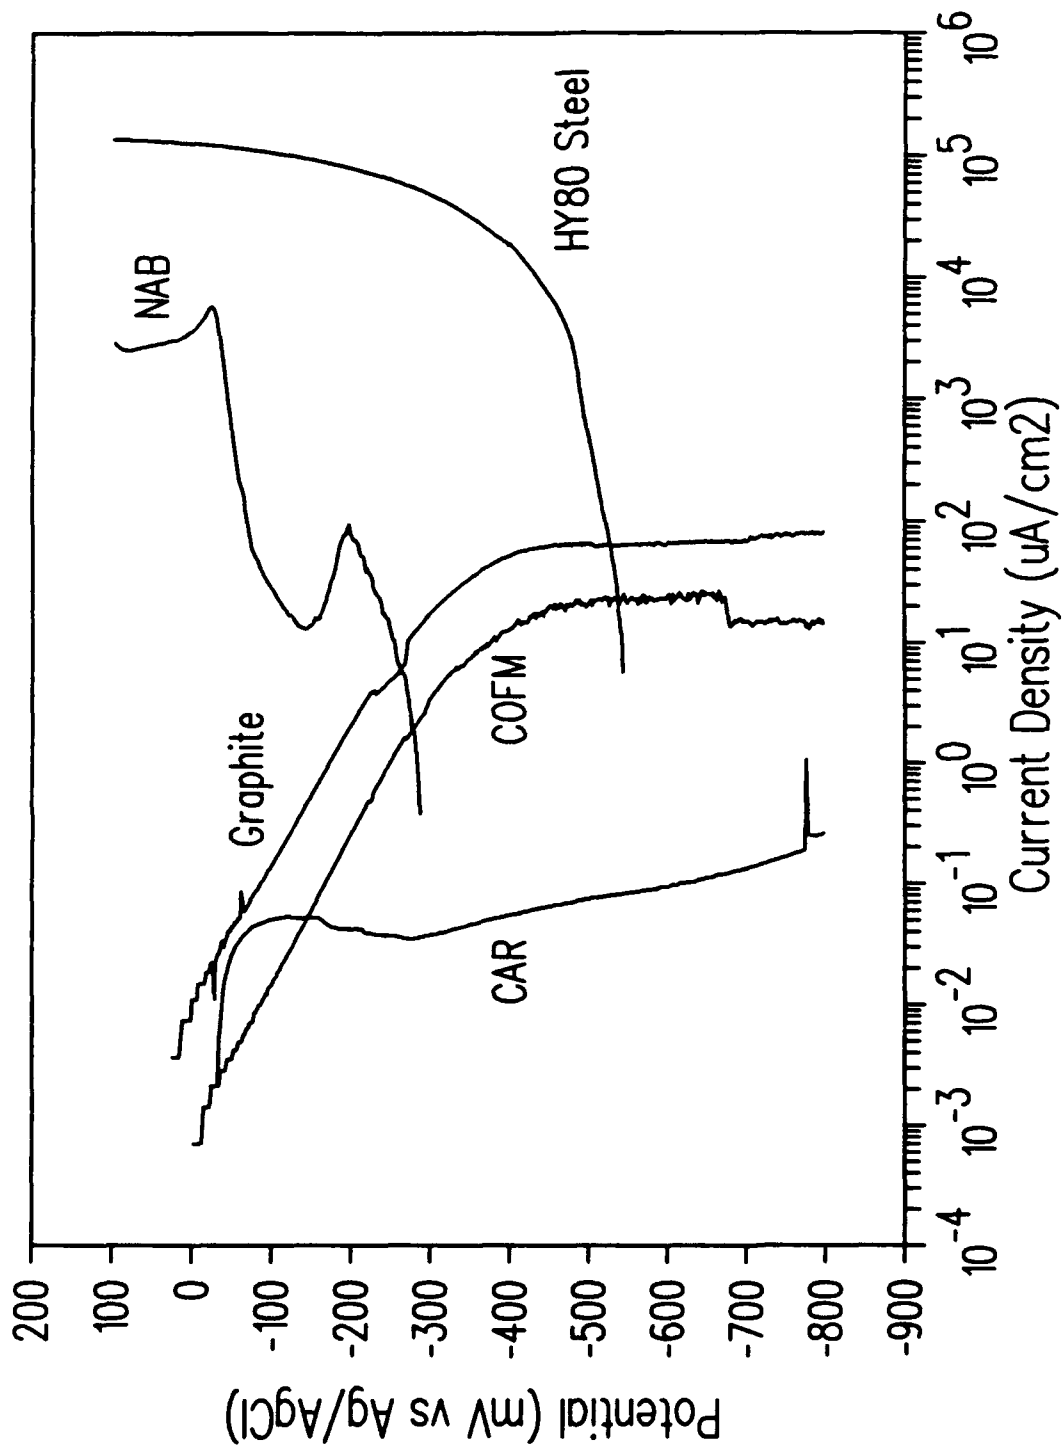
Note: CAR – As-fabricated Gr/epoxy (no graphite fibers initially exposed)
 COFM – Machine sanded Gr/epoxy (minimum 68% graphite fiber area initially exposed on surface)
 NAB – Nickel aluminum bronze

Figure 16. Potentiodynamic polarization behavior of Gr/epoxy composites and metals in seawater.

couple. Coupling NAB to the three cathodic curves (CAR, COFM, and pure graphite) yielded a couple E_{corr} of approximately -300 mV in all three cases due to the flatness of the anodic NAB curve. The couple corrosion current densities, however, varied from $0.04 \mu\text{A}/\text{cm}^2$ for the NAB-CAR couple to 2 and $7 \mu\text{A}/\text{cm}^2$ for the NAB-COFM and NAB-graphite couples, respectively. This approach showed a two-fold order of magnitude increase in the couple corrosion current density between the NAB-CAR couple with no graphite fibers initially exposed and the NAB-COFM (68% graphite fibers initially exposed) and NAB-pure graphite couples.

The HY80 material coupled to the three cathodic curves (CAR, COFM, and pure graphite) all showed a predicted couple E_{corr} of -550 mV due to the flatness of the anodic HY80 curve. The predicted couple corrosion current densities were significantly higher for the HY80 couples than for the NAB couples, but the data still indicated an increase in corrosion current density with increasing graphite area (as was found for the NAB-composite couples). The HY80-CAR couple showed a corrosion current density of $0.1 \mu\text{A}/\text{cm}^2$, and the HY80-COFM and HY80-graphite couples exhibited corrosion current densities of 20 and $80 \mu\text{A}/\text{cm}^2$, respectively.
